OHIO RIVER BASIN
TRIBUTARY OF HARMON CREEK , WASHINGTON COUNTY

PA-484 DAM
NDI I.D. NO: PA-489
DER I.D. NO: 63-72

PHASE I INSPECTION REPORT
NATIONAL DAM INSPECTION PROGRAM

D'APPOLONIA CONSULTING ENGINEERS
10 DUFF ROAD
PITTSBURGH, PA. 15235

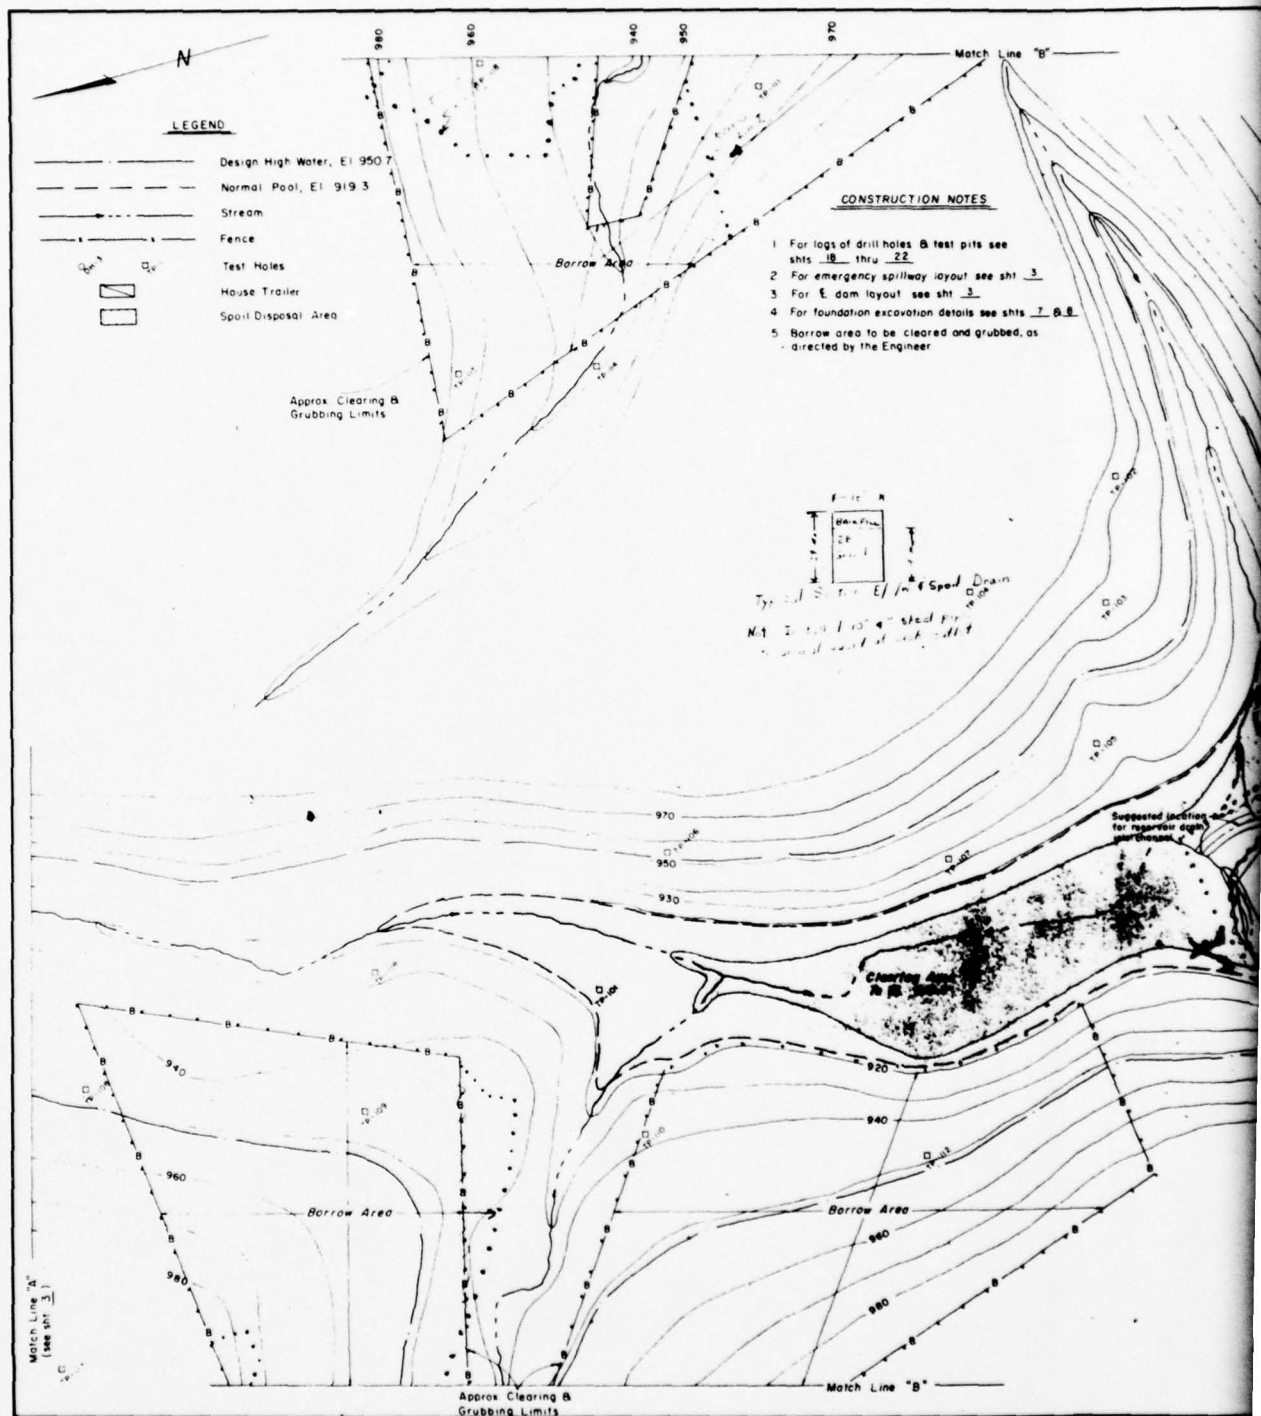
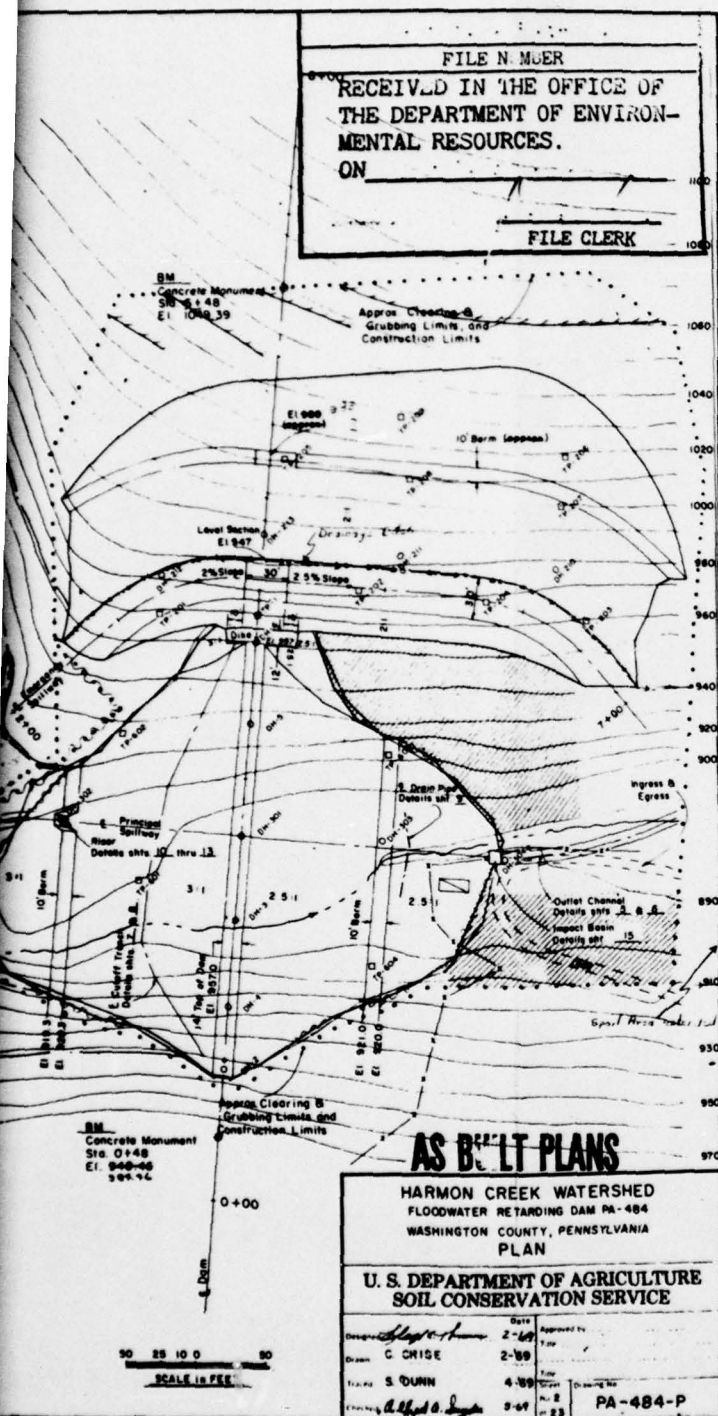
PLATE 2

a. As designed, the dam is a zoned embankment including an internal drainage system beneath the downstream slope (Plate 2). Plate 3 illustrates the typical cross section of the dam. Three zones and one transition zone are identified. A 12-foot-wide inclined zone (Zone I) constitutes the impervious core section of the embankment. The Zone I material was classified as silty clay containing 83 to 96 percent fines and with liquid limits in the range of 44 percent and plasticity index in the range of 22. Zone I starts at a level five feet below the dam crest and terminates at a cut-off trench beneath the upstream slope. A five-foot-thick blanket of Zone I material covers the foundation from the upstream toe to the base of the core. Zones II and III constitute the shell sections of the embankment. Zone II material was described as weathered siltstone. The fines of this material had liquid limits in the range of 40 percent and the plasticity index in the range of 16. The Zone II material, the lower portion of the downstream shell, was described as weathered sandstone. A 35-foot-wide filter blanket beneath the downstream toe constitutes the internal drainage system of the embankment and was extended up the abutments to intersect the

- c. The subsurface investigation conducted for the dam consisted of numerous borings and test pits. The locations of these borings are shown in Plate 2. Selected boring logs are illustrated in Plates 5 and 6. A typical subsurface profile (Plate 7) consists of up to 6-1/2 feet of colluvium on the left abutment and 3-1/2 to 8 feet of alluvium at the valley bottom. On the right abutment, bed-rock is at the surface. The rock beneath the site includes silts and sandstones. The Ames Limestone was encountered approximately 37 feet below the dam crest elevation. It is reported that rock permeability rates varied significantly between the different rock units. Permeabilities in the abutments, except in the Ames Limestone, ranged between no take and 6.2 feet per day (2×10^{-3} cm/sec). In the limestone, sandstone, and siltstone at the valley floor, permeabilities up to 30 feet per day (10^{-2} cm/sec) were measured.

The emergency spillway is a trapezoidal earth channel excavated into the left abutment (Plate 2). The bottom width of the trapezoidal channel is 30 feet with side slopes 2:1 on both embankment and abutment sides. A 30-foot-wide level section located at Elevation 947 in line with the axis of the embankment constitutes the controlled section of the spillway.

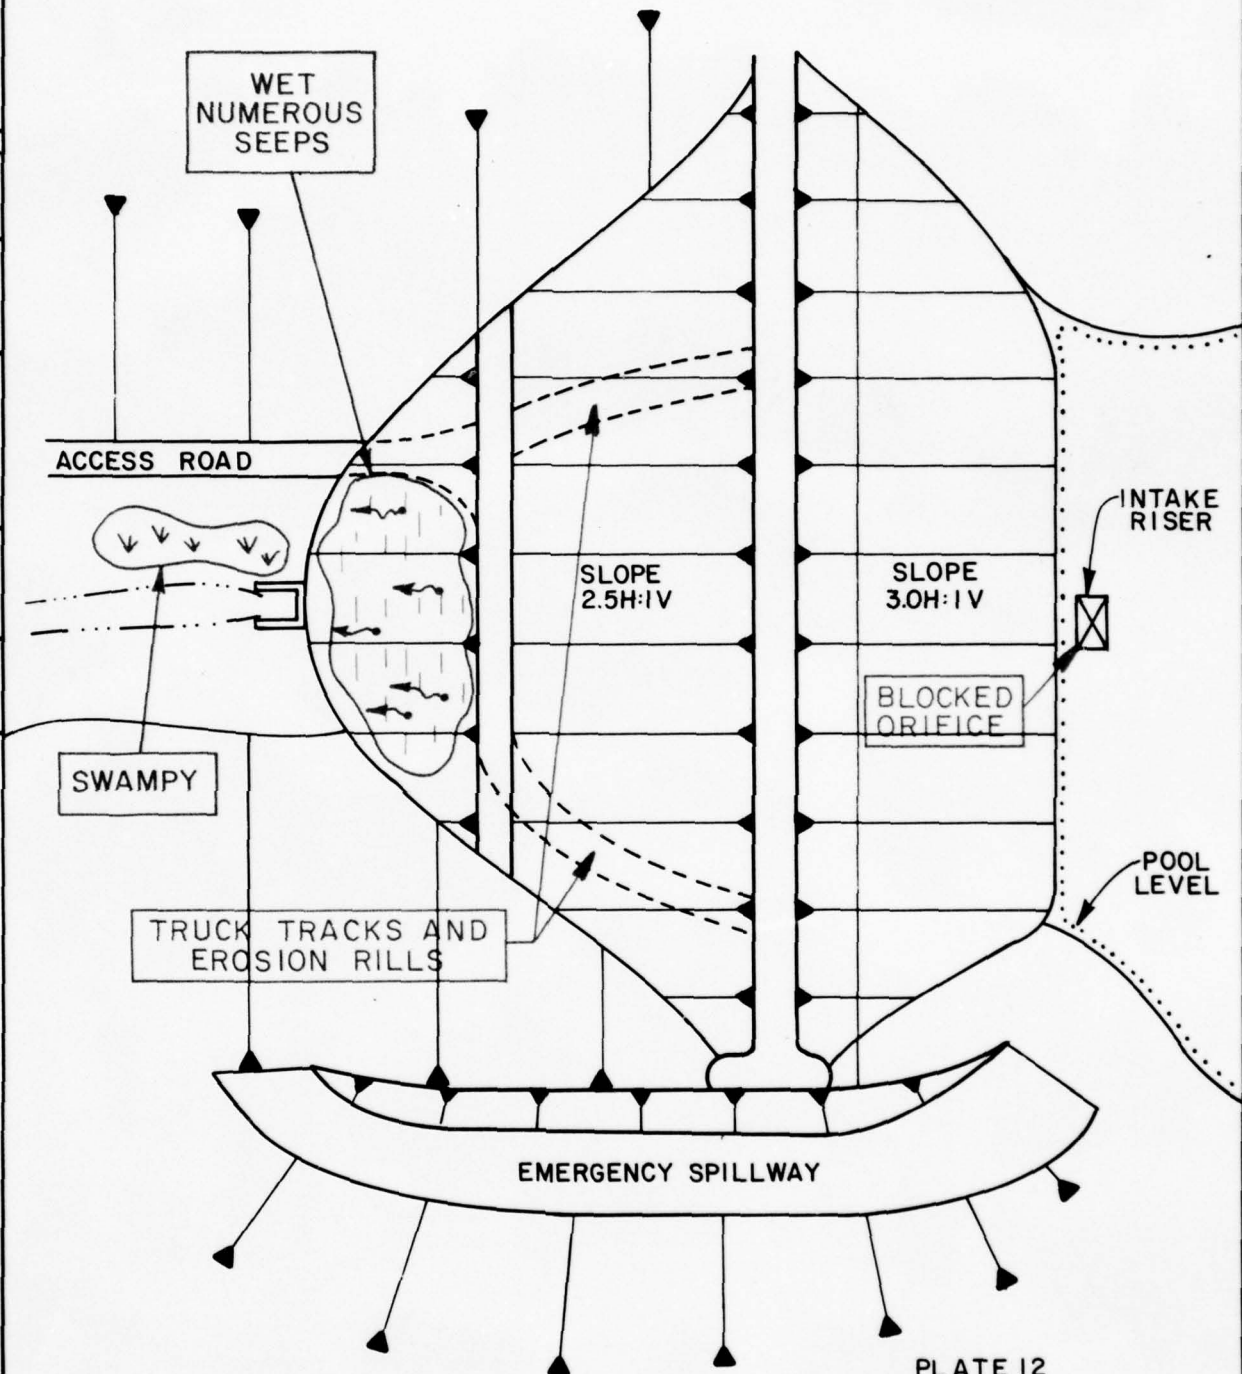
1. EMERGENCY SPILLWAY
FREEBOARD: 9.6 FT.
2. POOL LEVEL DATE OF
INSPECTION: 18.7 FT. BELOW
CREST OF DAM
